DATE: 4/2018

REVISED: 8/22/2018

TOPIC: Installation Instructions / Battery Disconnection / OCS System Reset

VEHICLE: 2018 Jeep Wrangler JL

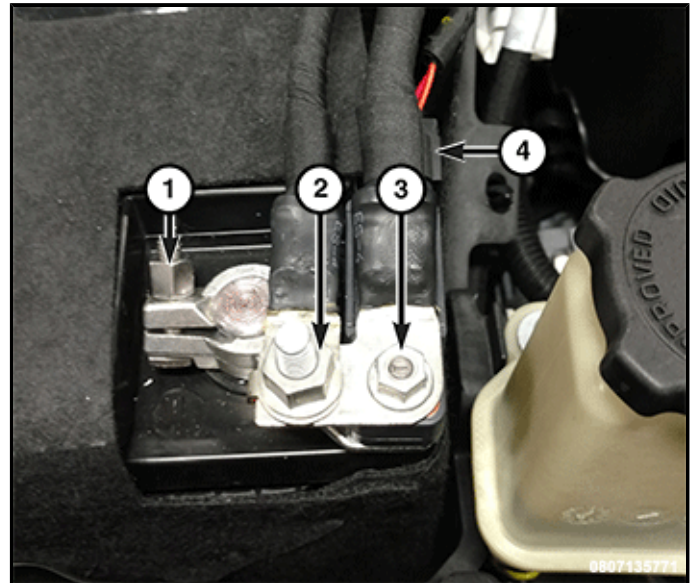
1. Remove the nut (2) for the supplemental battery negative cable and isolate the cable.
2. Remove the nut (3) for the main negative cable and isolate the cable.
3. If you loosen the nut (1) and isolate the negative cables it will not disconnect the battery connection for the supplemental battery and the system will have the ability to power up.
4. Disconnection of the IBS (4) will not isolate the battery system and will still allow the system to power up.

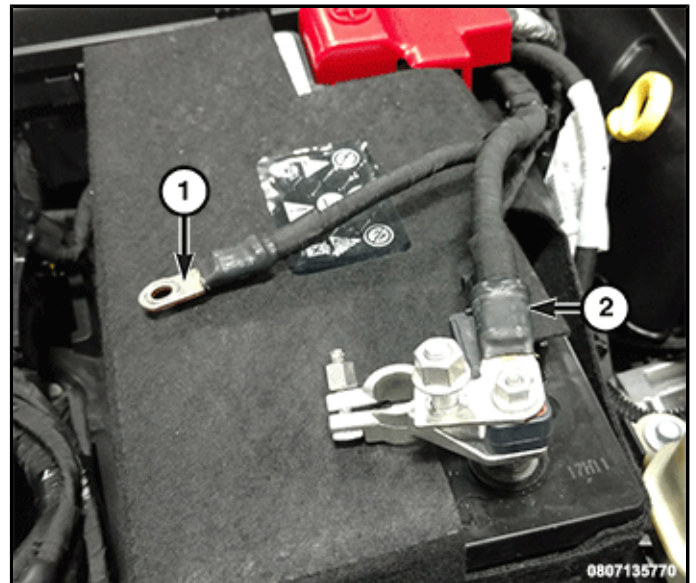
5. In this image you can see that the Supplemental negative cable (1) is disconnected and the main battery cable (2) is still connected but off the battery post. This is acceptable, but you will need to isolate the clamp from touching the negative battery post.

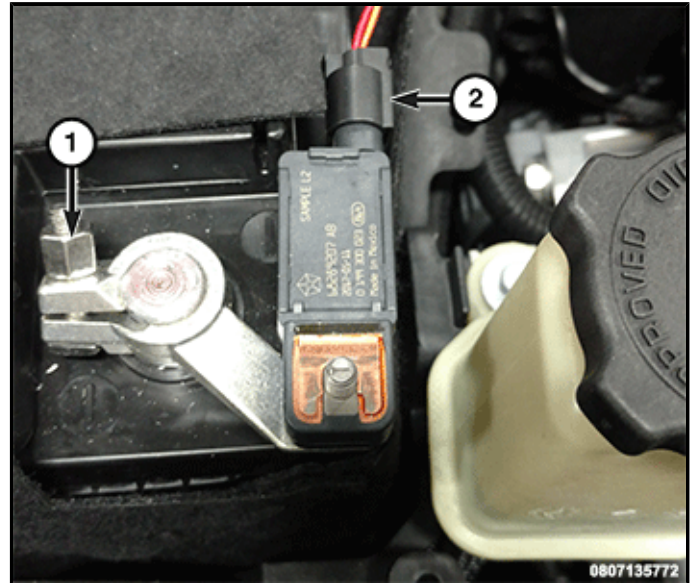
6. This image shows the battery system completely isolated and leaving the battery clamp (1) still in place and the IBS (2) still connected.

7. Once all repairs are completed, you will need to connect the cables and or the clamp and tighten to the proper (Torque Specifications).
