DATE: 4/2018

TOPIC: Installation Instruction / OCM System Reset

VEHICLE: 2018 Jeep Wrangler JL

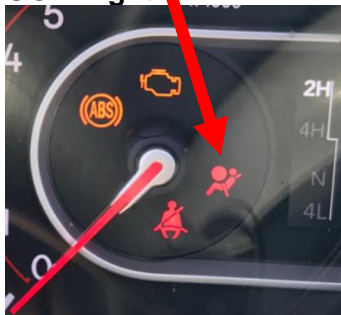
OCM Light

The OCM (Occupant Classification Monitor) within the new JL seat is highly sensitive to movement. Because of this sensitivity, there is a chance that the OCM light will remain on after completing a Katzkin leather installation and returning the seats to the vehicle. Follow these instructions as outlined, and you may not encounter this issue.

If you do encounter this issue, the Wrangler must be taken to an FCA dealership for a reset after the completed installation. Only the dealerships will have the tools necessary for the system reset.
