DATE: August 25, 2020

TOPIC: 2007-18 Jeep Wrangler JK 4-Door, Rear 60% cushion

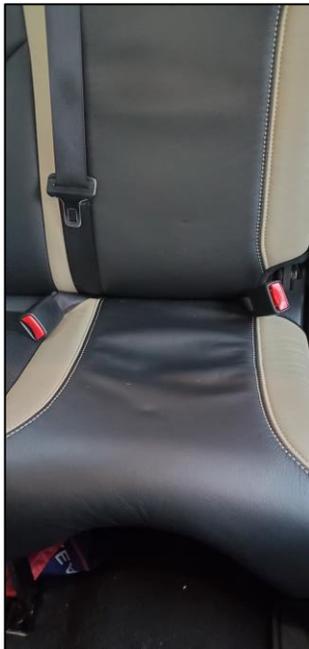
(Fig.1)

In certain instances, a customer may notice that there is “sag” in the middle section of the rear seat (60%).

If the vehicle owner carries any kind of cargo directly on the seat with or without the lean backs folded, or prolonged adult passenger use of the middle rear 60% cushion, the foam will begin to cave in (Fig.1). The rear 60% cushion has unsupported foam on the underside (see Fig.2).

This issue is not related to the Katzkin produced leather seat cover and the corrective action will involve work with the foam directly.
